BELL HELICOPTER TEXTRON FORT WORTH TX
AH-1S HIGH-SURVIVABLE TRANSMISSION SYSTEM.(U)
OCT 79 G A COPE

AD A 080 568
AH-1S HIGH-SURVIVABLE TRANSMISSION SYSTEM

Final Report for Period October 1977 - December 1978

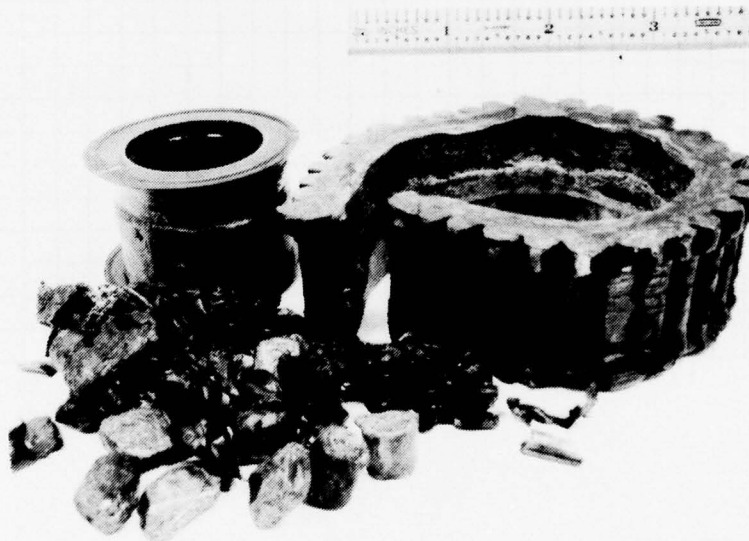
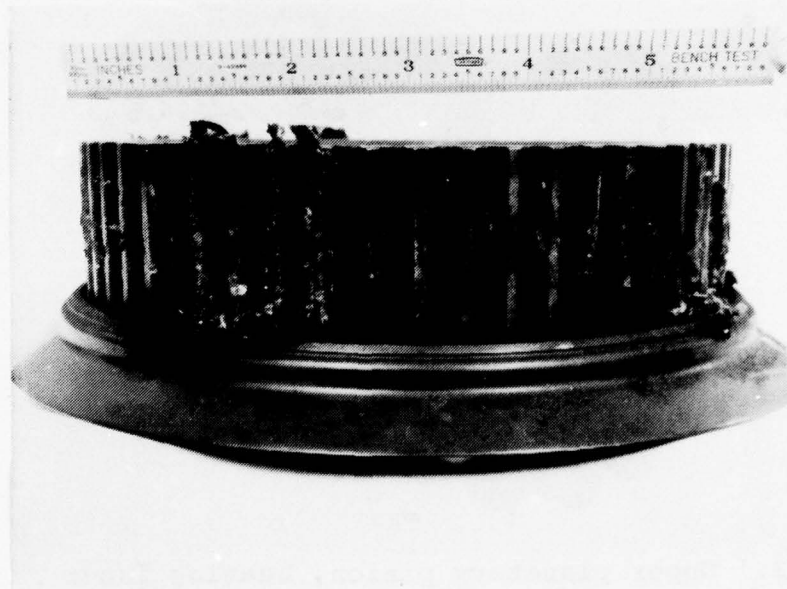
Figure 18. Lower planetary pinion, bearing inner race, roller, roller guides, and retainer after 25-minute loss-of-lube test of optimized transmission configuration number 1.

Figure 19. Lower sun gear after 25-minute loss-of-lube test of optimized transmission configuration number 1.

Figure 20. Upper sun gear after 25-minute loss-of-lube test of optimized transmission configuration number 1.

Figure 21. Upper planetary assembly after 25-minute loss-of-lube test for optimized transmission configuration number 1.

Figure 22. Upper planetary pinion, bearing inner race, rollers, roller guides, and retainer after 25-minute loss-of-lube test of optimized transmission configuration number 1.

Debris in the form of chewed-up and misshapen rollers and pieces of bearing retainers were strewn throughout the transmission. The lower planetary sun gear teeth had softened and were beginning to roll over. Both the sun gear and the planetary pinions are carburized gears. The lower ring gear, which is nitrided, had some chipped teeth and had been damaged by debris, but there was no indication that the ring gear teeth had softened.

The upper planetary was dry and had been damaged extensively by debris from the lower planetary, but it was still capable of continuing operation. The roller bearings were contaminated by debris from the lower planetary stage but were still functional. The bronze bearing retainers appeared to be in good condition.

It was not possible to ascertain the primary mode of failure in the lower planetary stage by examining the failed components. The failure had progressed to such an extent that both gears and bearings were badly deformed and no specific causations could be positively established. The combination of high loads and high temperatures forced the failure of the lower planetary pinions. Apparently, at the high temperatures of no-lube planetary operation the planetary pinions softened and distorted under predesign heavy gear loading, causing increased heat generation at both gear meshes and in the planetary roller bearing. This led to the oblong shape of the pinions and to the failed bearings and gear teeth.

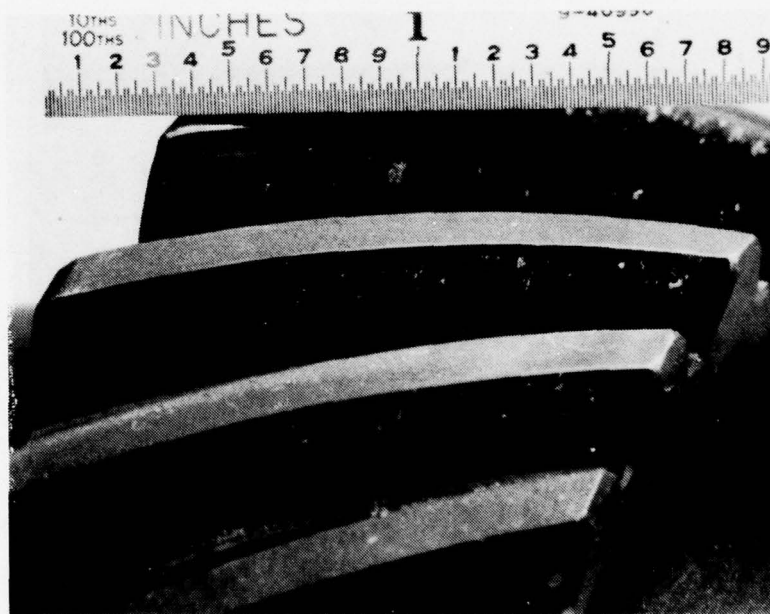
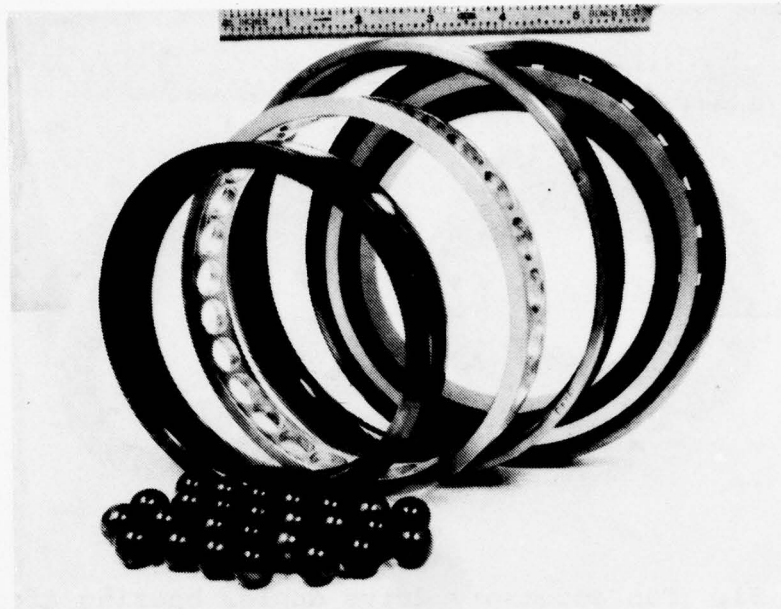
Figure 25. Main input pinion after 25-minute loss-of-lube test of optimized transmission configuration number 1.

Figure 26. Main input pinion teeth (drive side) showing light scoring after 25-minute loss-of-lube test of optimized transmission configuration number 1.

Figure 27. Main input gear and gearshaft after 25-minute loss-of-lube test of optimized transmission configuration number 1.

Figure 28. Main input gear teeth (drive side) showing light scoring after 25-minute loss-of-lube test of optimized transmission configuration number 1.

Figure 29. Main input triplex bearing after 25-minute loss-of-lube test of optimized transmission configuration number 1.

Figure 30. Main input pinion roller bearing after 25-minute loss-of-lube test of optimized transmission configuration number 1.

Figure 31. Main gearshaft duplex bearing after 25-minute loss-of-lube test of optimized transmission configuration number 1.

The teeth of the main input spiral bevel gear set were moderately scored after the 25-minute loss-of-lube run. The triplex ball bearing and the roller bearing that support the main input pinion still had slight traces of oil when removed from the transmission. The balls and rollers (which are made of M-50 steel) had a bluish tint as a result of the high temperature operation, but the bearings still turned smoothly and, seemingly, suffered no real damage. The duplex ball bearing that supports the main input gearshaft was still functional but had suffered debris damage and turned roughly. The balls of the duplex bearing (made of M-50 steel) also had a bluish tint as a result of the high temperature operation.

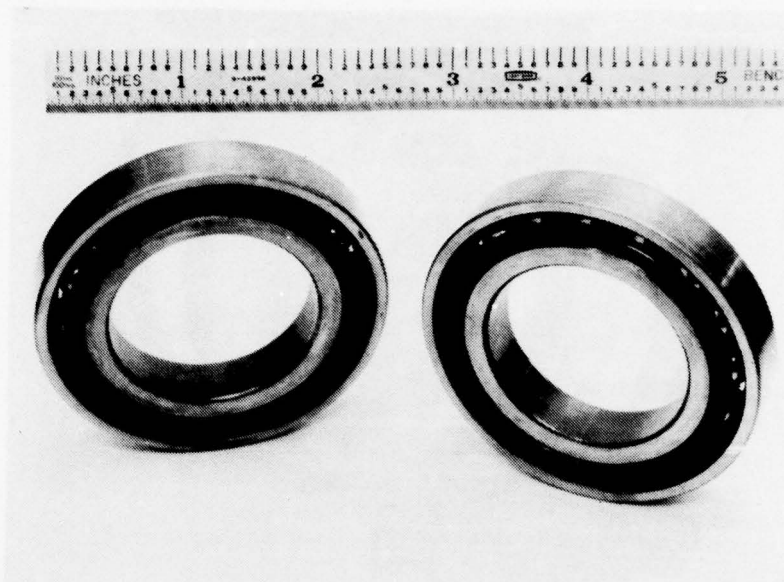
Figure 33. Fan accessory drive duplex bearing after 25-minute loss-of-lube test of optimized transmission configuration number 1.

Figure 34. View looking into ring gear case after 25-minute loss-of-lube test of optimized transmission configuration number 1.

Figure 35. View looking into main and support cases after 25-minute loss-of-lube test of optimized transmission configuration number 1.

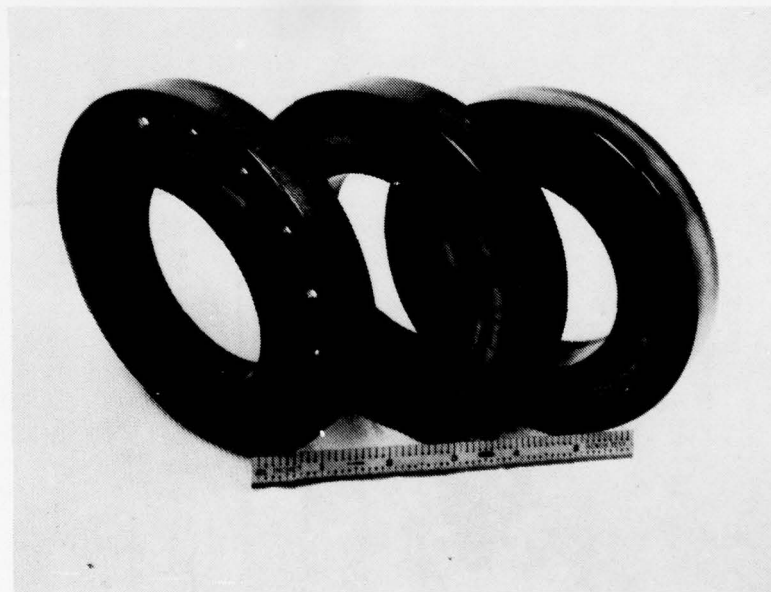
Figure 58. Main input pinion after 54-minute loss-of-lube test of optimized transmission configuration number 2.

Figure 59. Main input pinion teeth (drive side) showing light scoring after 54-minute loss-of-lube test of optimized transmission configuration number 2.

Figure 60. Main input gear and gearshaft after 54-minute loss-of-lube test of optimized transmission configuration number 2.

Figure 61. Main input gear teeth (drive side) showing light scoring after 54-minute loss-of-lube test of optimized transmission configuration number 2.

Figure 62. Main input triplex bearing after 54-minute loss-of-lube test of optimized transmission configuration number 2.

Figure 63. Main input pinion roller bearing after 54-minute loss-of-lube test of optimized transmission configuration number 2.

Figure 64. Main gearshaft duplex bearing after 54-minute loss-of-lube test of optimized transmission configuration number 2.

The teeth of the main input bevel gear set were moderately scored after the 54-minute loss-of-lube run. The triplex ball bearing and the roller bearing that support the main input pinion still had slight traces of oil when removed from the transmission. The balls and rollers (which were made of M-50 steel) had a bluish tint as a result of the high temperature operation, but the bearings still turned smoothly and, seemingly, suffered no real damage.

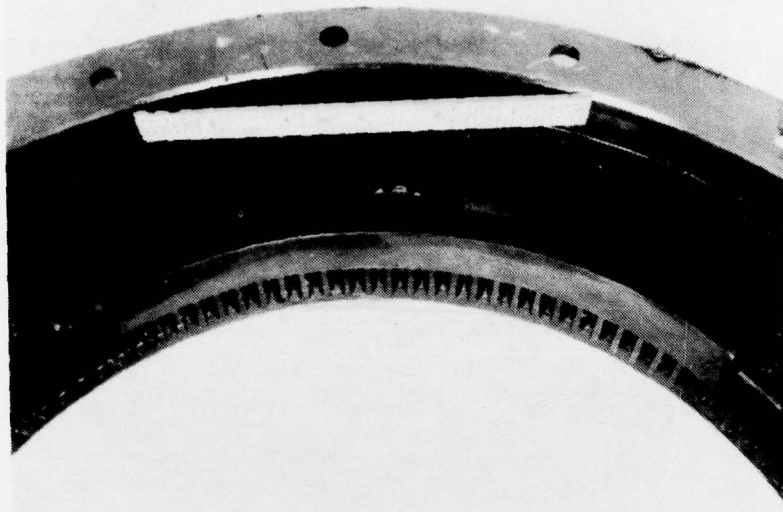
Figure 67. View looking into ring gear case showing lower oil collectors after 54-minute loss-of-lube test of optimized transmission configuration number 2.

Figure 68. View looking into ring gear case showing debris in lower oil collectors after 54-minute loss-of-lube test of optimized transmission configuration number 2.

Figure 69. View showing lower oil collector in ring gear case after 54-minute loss-of-lube test of optimized transmission configuration number 2.

Figure 70. View showing upper oil collector in top case after 54-minute loss-of-lube test of optimized transmission configuration number 2.

Figure 71. Upper oil collector after 54-minute loss-of-lube test of optimized transmission configuration number 2.

The lower oil collectors were dry and contained some debris. The felt on the back of the lower oil collectors was burned black and was brittle due to the high temperature of the ring gear case during the loss-of-lube test number 2. The upper oil collector was drained of lubricant but was covered by an oil film.
